USAAVLABS TECHNICAL REPORT 68-88

T63 REGENERATIVE ENGINE PROGRAM (EXTENDED ENDURANCE AND ENVIRONMENTAL TESTING)

CONTRACT DA 44-177-AMC-293(J)
ALLISON DIVISON, GENERAL MOTORS
INDIANAPOLIS, INDIANA

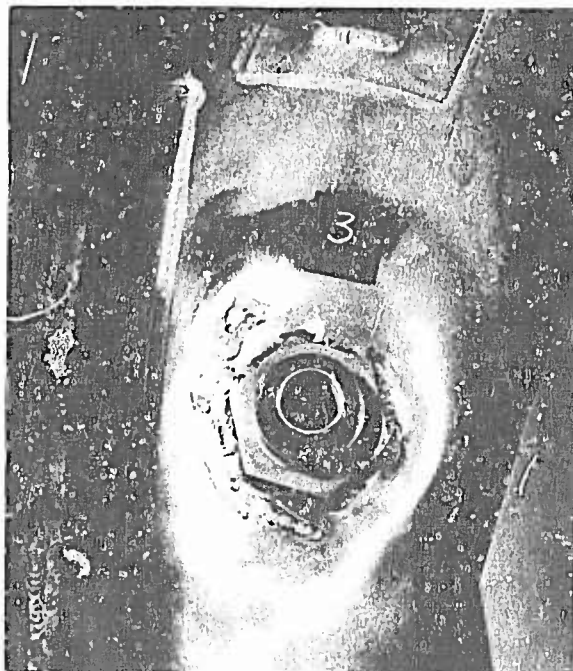
Figure 6. Weld-Repaired Air Inlet Duct.

The regenerator on the right side was removed twice during the endurance test for weld repair of cracks that developed in the inlet air duct at the auxiliary turbine cooling air fitting; a loss of power of 9 to 13% at 1380°F TOT resulted. The weld beads show the location of these cracks in Figure 6.

The regenerators successfully completed a 150-hour endurance test with no evidence of serious deterioration. The sheet metal cracks in the air inlet duct could be eliminated by use of a doubler between the duct and the fitting. The exhaust ducting cracks were a result of wrinkles in the sheet metal which would be eliminated by production tooling.

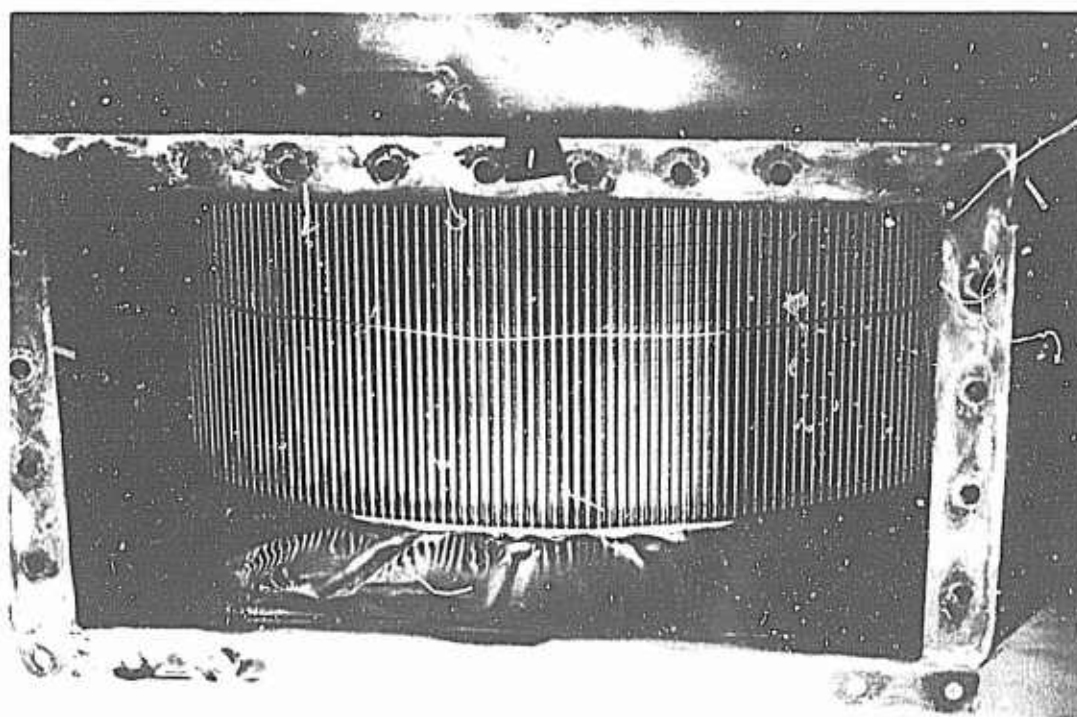
Figure 10. P/N 6858502 Regenerator After Carbon Fouling Test.

As mentioned previously, approximately five quarts of oil went through the regenerators after the postendurance calibration. This oil passed through the regenerator in a liquid state as shown in Figure 10. The liquid oil removed all carbon deposits from the outside of the tubes. There was also some evidence of coked oil on the tubes at the junction of the tubes to the header. However, the high oil consumption occurred after the completion of the postendurance calibration. Therefore, the performance evaluation before and after the 3-hour idle run was valid.

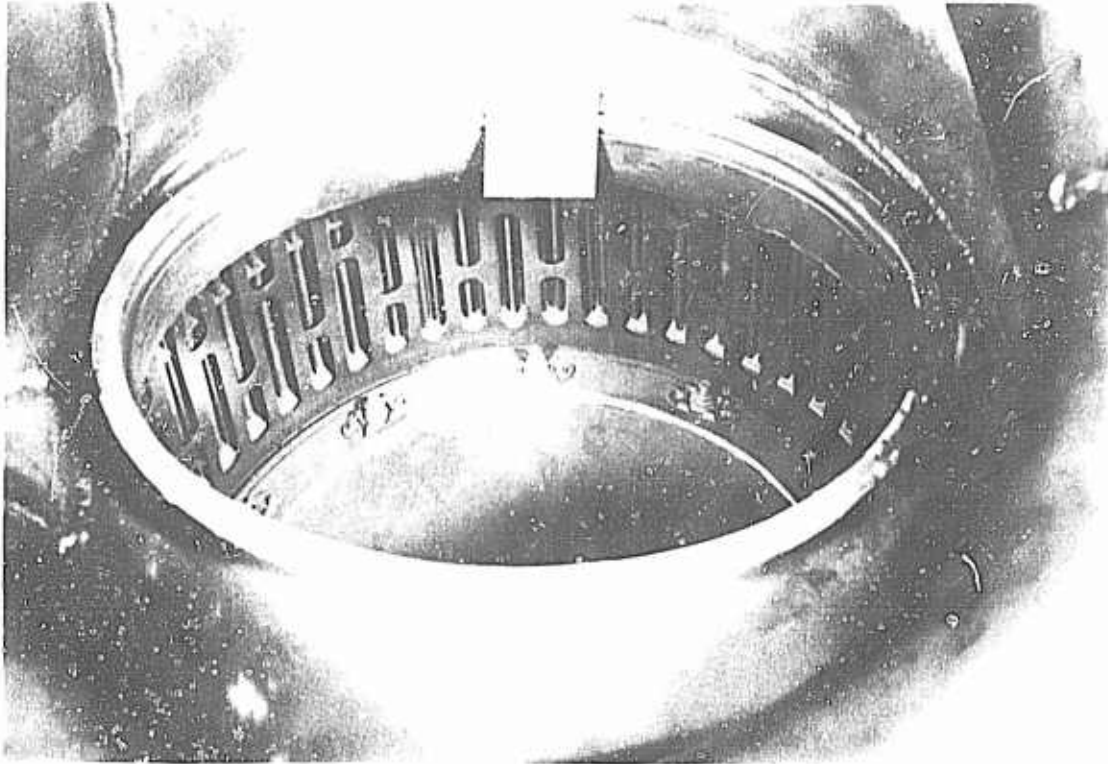
Figure 15. P/N 6858501 Regenerator (Left Side) After Dust Ingestion.

One of the potential problem areas in the regenerator is dust collection in the air inlet and outlet ducts. To determine the amount of dust collected in the regenerators, the regenerators were weighed before and after the dust ingestion test. The increase in weight was 0.04 pound on the left-hand regenerator and 0.07 pound on the right-hand regenerator. This increase in weight is not considered to be significant. Figures 15 and 16 show the left-hand regenerator after the dust ingestion test. There was some indication of a scale formation on the first row of tubes (gas inlet)

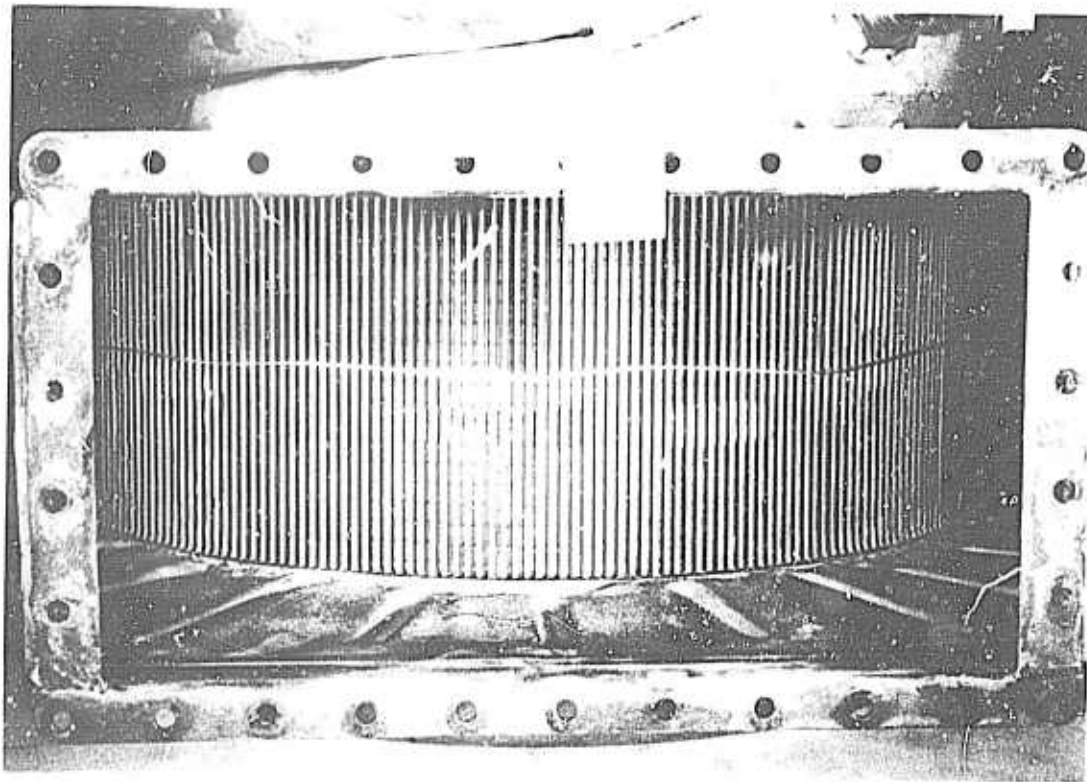
Figure 16. P/N 6858501 Regenerator (Left Side) After Dust Ingestion.

as shown in Figure 15. On the gas outlet side there was a film of dust collected, as shown in Figure 16. The tubes were wiped in the center to give some indication of the thickness of the film.

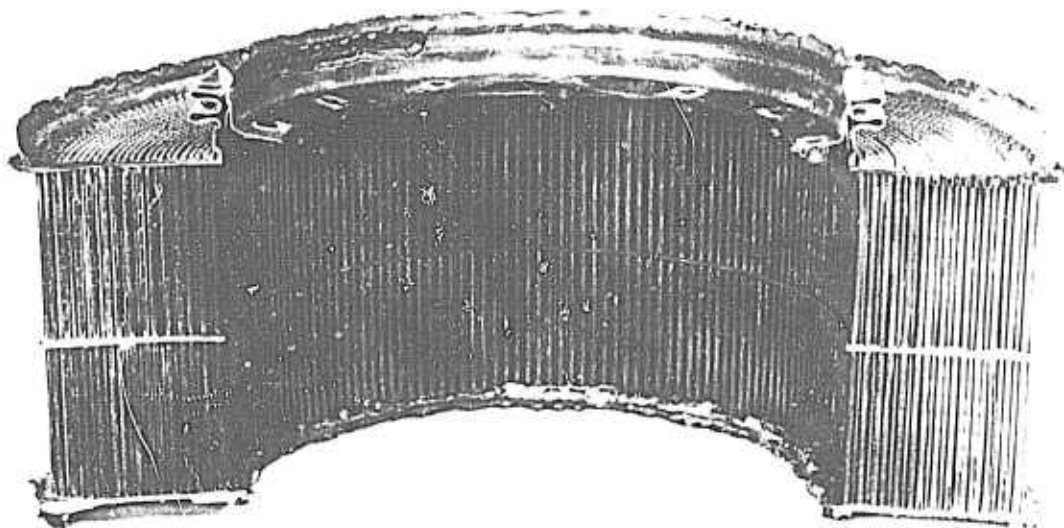
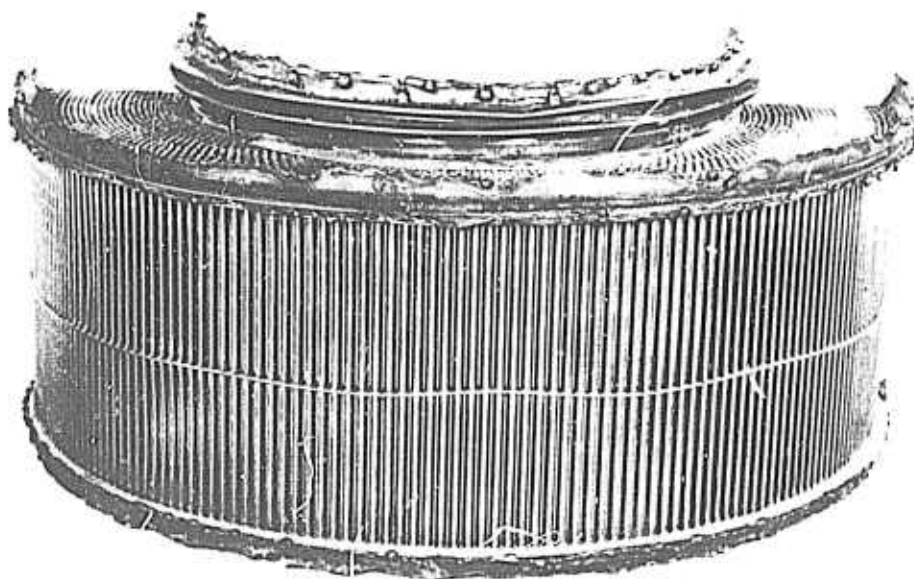
Figure 20. Gas Side of Regenerator Core—Second Pass.

Figures 20 and 21 show the condition of the second pass of the regenerator core. Again, there was no visual indication of erosion or damage to the tubes as a result of the dust ingestion. There was no evidence that the scale on the gas inlet side was more pronounced than the scale on the first pass.

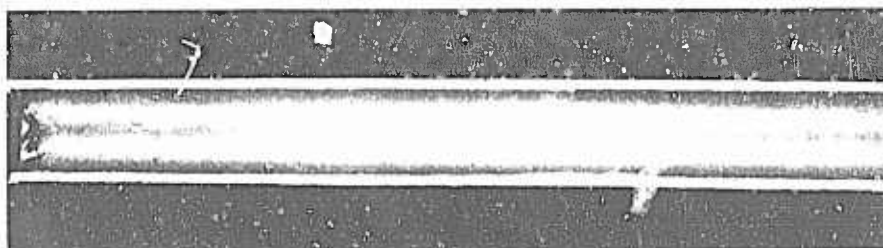
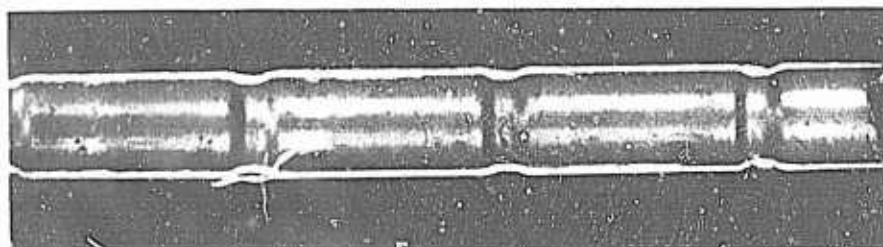
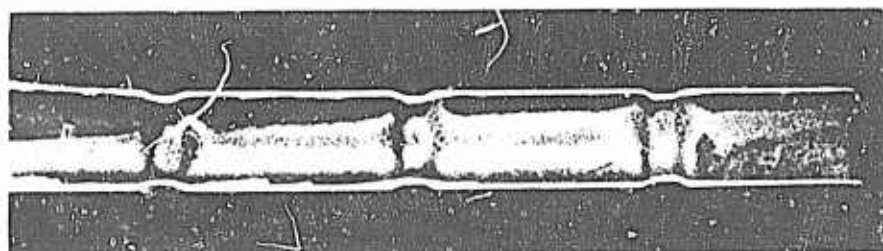
Figure 23. Inside Diameter of Gas Inlet Tubes—6X View.

Figure 23 shows the typical condition of the inside diameter of the tubes. All tubes in both the first and the second pass were very clean, with the exception of braze on the ID of some tubes in the vicinity of the tube-to-header braze joint.

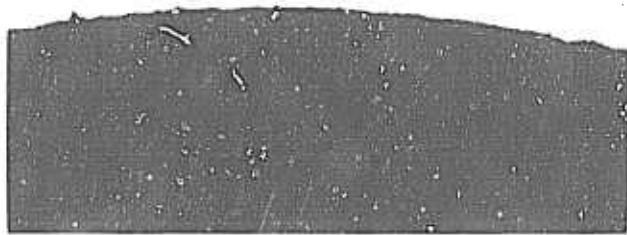
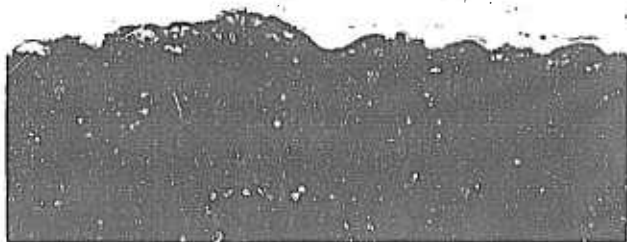
Figure 24. Cross Section of Gas Inlet Tubes—200X.

In general, the metallurgical investigation showed that the regenerator was in excellent condition after 10 hours of dust ingestion and a total of 106 hours engine testing.

Oxidation on ID of Tube with Braze
(Second Pass—Second Row)
